TECHNICAL TIP

Rover 75 / MGZT
Petrol Derivatives

No: TBX0501

FUEL PRESSURE – LITTLE OR NO FUEL PRESSURE

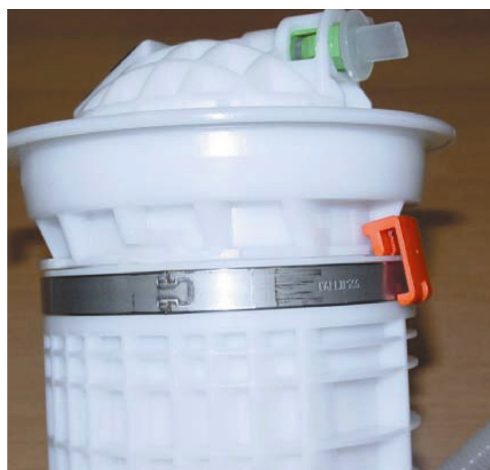
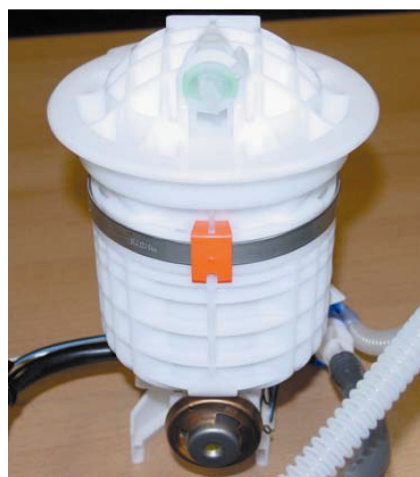
A number of vehicles have experienced problems arising from low or non-existent fuel pressure leading to an engine non-start condition. It is possible that the lack of fuel pressure may be down to the fuel filter assembly coming apart. Previously this would have necessitated a new fuel filter assembly to be fitted.

1. Remove the fuel filter housing in accordance with the repair operations manual. Please pay particular attention to the fuel safety warnings.
2. Inspect the upper and lower section of the filter to ensure they are fully locked together.
3. If required relock the housing as necessary.
4. Fit new locking clip. Part No WJC000230, ensuring the centre of the clip locates around the strengthening web as shown below.
5. Refit the fuel filter housing in accordance with the repair operations manual.

NOTE: If a new fuel filter assembly is fitted or the assembly is dismantled as part of a repair it will also be necessary to fit a retaining clip. There are no plans to modify the new assemblies.

Fuel Module Retaining Clip – 1 off required Part No **WJC000230**
