Crankshaft oil seal adaptor. Fitting Instructions

1300 engine: Midget/Marina/Ital

Crankshaft oil seal adaptor. Fitting Instructions / Stage 2

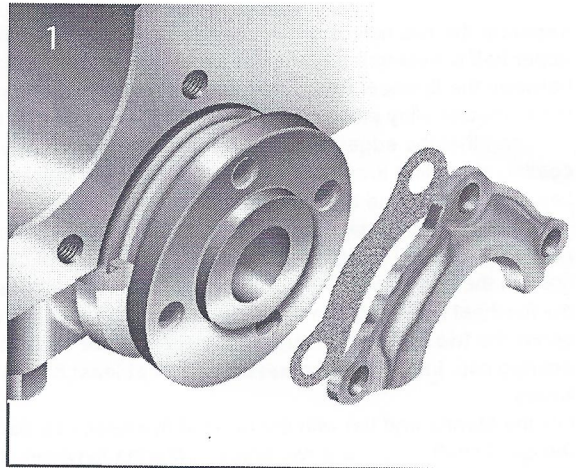
Remove the flywheel, back plate and the half round cover above the rear main bearing cap. Carefully clean up the rear block face adjacent to the main bearing cap (fig 1), removing all traces of the gasket and burrs etc. The new oil seal will run on the outer horizontal edge of the flywheel mounting flange on the crank. This will need to be checked for damage and carefully polished smooth with wire wool or fine emery.

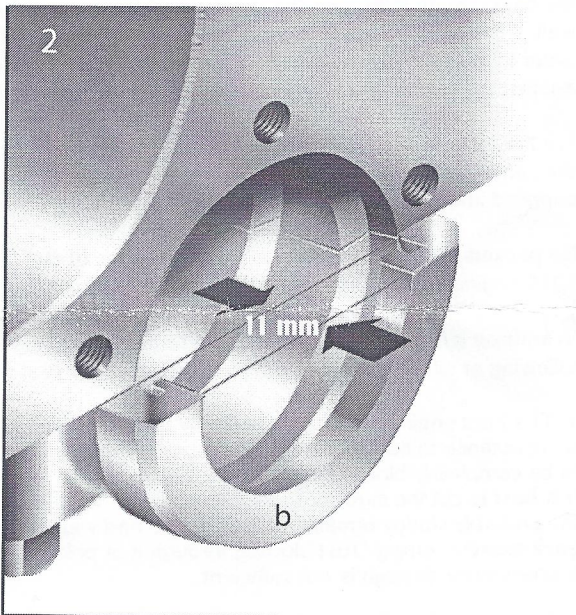
Looking at the main bearing cap, you will see that the end face (fig 2 & 3) is already machined flat. However the height of this end face from the block is critical to the sealing of this kit, and must be carefully measured. There needs to be a dimension of 11mm from the block face to the main bearing cap. This must be both flat and square to the block (fig 3) but it is unlikely you will have to do anything with this dimension on the 1300 engines as it seems fairly stable from new, but check it anyway.

The triangular alloy part of this kit is also 11mm thick and when screwed to the block its outer face must be level with the end face "b" of the main bearing cap throughout its length (see fig 2). This part of the fitting process is the longest and requires a good deal of accuracy, as it is essential to the complete sealing of the kit to the block. Experience has shown that the 11mm dimension is fairly consistent on production engines, however should adjustment be needed this measurement can be achieved either by surface grinding, or very careful filing. Either way accurate measuring is essential. In the very unlikely event of the height already being more than 11mm, you can remove up to 1mm from the triangular alloy part to compensate.

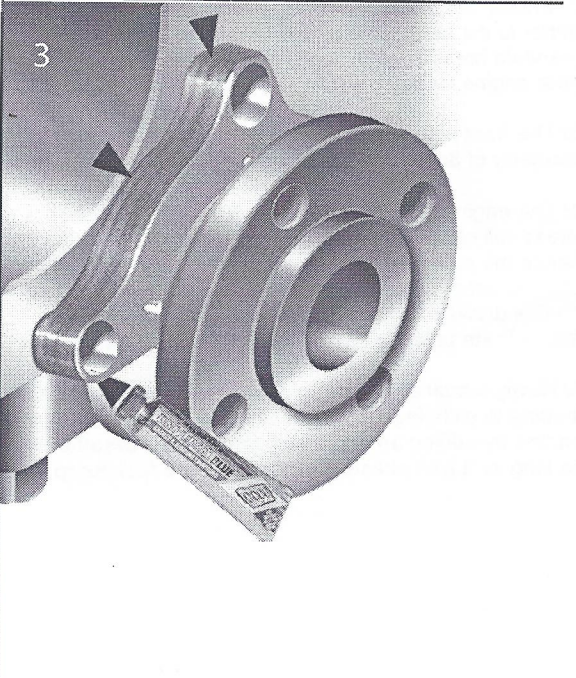
Apply a coating of sealant to the mating faces of the triangular alloy part where it meets the block and the main bearing cap, but do not use a gasket. Fig 4. Position on the block ensuring that it sits centrally against the main bearing cap faces and the three screw holes line up.
